# Filmic Corrosion Inhibitor: Venezuelan East Refinery FCC Unit

A refinery located east of Venezuela has an FCC unit with a capacity of 15,000 bbl/day. This unit has an H<sub>2</sub>S stripping tower to stabilize the FCC naphtha. Every three months, the failure of the FCC naphtha reboiler in the naphtha side housing rich in H<sub>2</sub>S caused unplanned plant stops. ChemTreat and the refinery established a work plan to determine the corrosion mechanism and correct the issue.

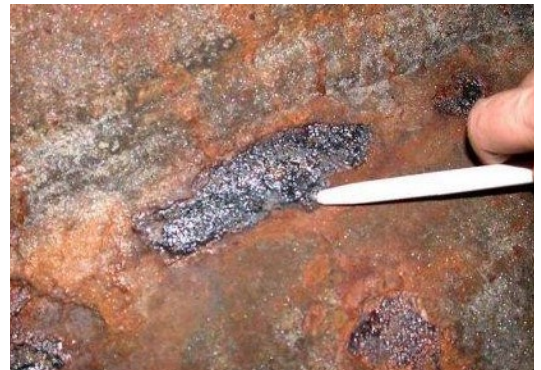
Figure 1: Photo of the Issue

As shown in Figure 2, the presence of water, carbon steel, and H<sub>2</sub>S produce ferric sulfide. In the presence of HCN (a gas that forms in FCC), ferric sulfide reacts to form atomic hydrogen. When it bonds with another hydrogen atom, there is a sudden strong increase in localized pressure as a result of the molecular hydrogen formation. This sudden pressure increase inside metal produces the blistering shown in Figure 1.

ChemTreat's recommendation was based on cutting the formation mechanism of the atomic hydrogen through the application of a film amine capable of forming a protective film on the carbon steel. The recommended product was Lipesa 229, and the point of injection was the feeding of destabilized naphtha to the stripping tower.

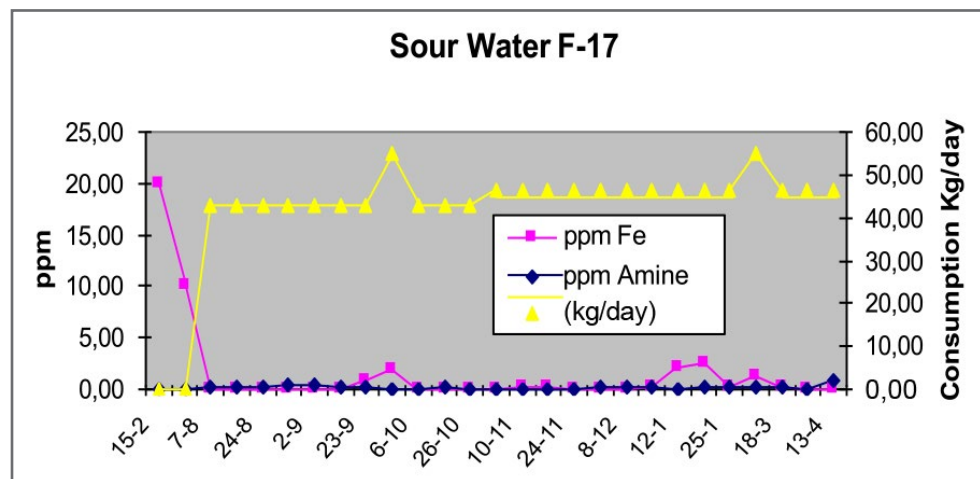
Figure 3: Treatment Results

Figure 3 illustrates that as soon as the Lipesa 229 injection was started, iron ppm fell on the F-17 drum (sour water) from more than 20 ppm to less than 1 ppm at a consumption of only 45 kg/day. The Lipesa 229 has been injected without interruption, and the blistering failure has not been repeated.
