TITAN360™

Provides Superior Corrosion Protection

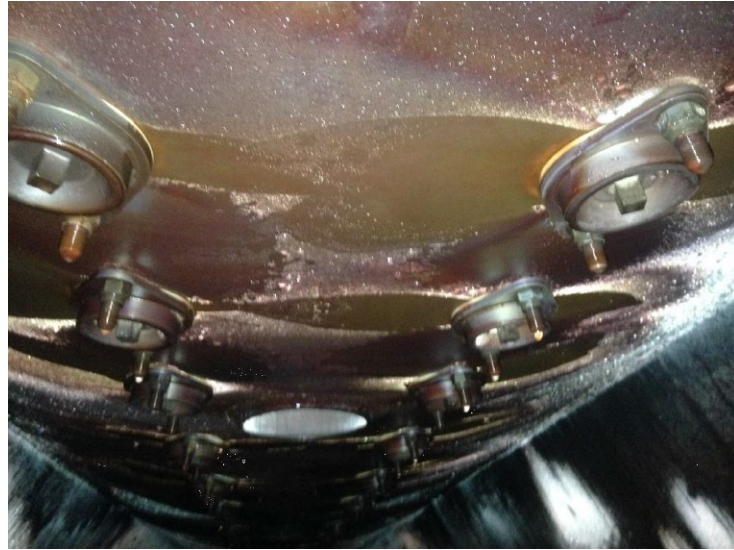
Figure 1: Deaerator dome and spray nozzles with water droplet accumulation

A boiler inspection revealed that TITAN360™ formed a protective film in the early sections of the cycle. The most prominent filming was prevalent up through the deaerator. This was evident by the non-wetted metal surfaces and presence of beaded water droplets, which can be seen in Figures 1 and 2. The deaerators had an excellent surface oxide passivation for all visible areas and there was no sign of any active corrosion or flow accelerated corrosion on any surface or internal component.

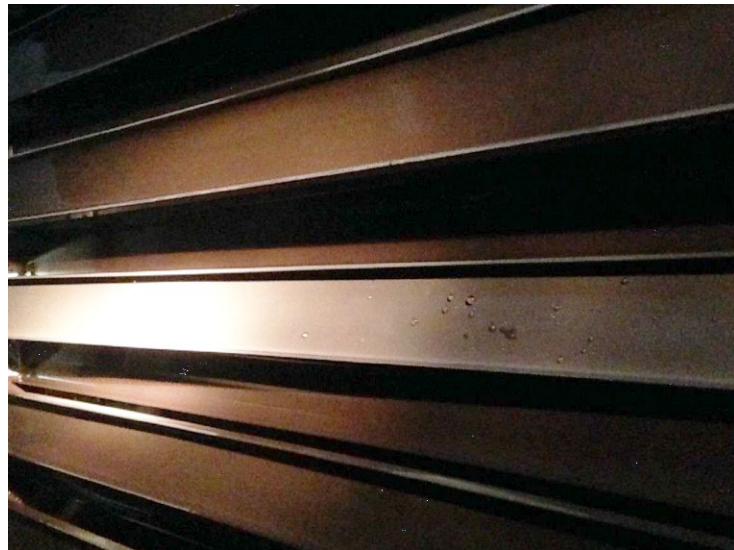
Figure 2: Deaerator trays with non-wetted surface and beaded water droplets.
