# Filmic Corrosion Inhibitor: Venezuelan East Refinery FCC Unit

A refinery located east of Venezuela has an FCC unit with a capacity of 15,000 bbl/day. This unit has an H<sub>2</sub>S stripping tower to stabilize the FCC naphtha. Every three months, the failure of the FCC naphtha reboiler in the naphtha side housing rich in H<sub>2</sub>S caused unplanned plant stops. ChemTreat and the refinery established a work plan to determine the corrosion mechanism and correct the issue.

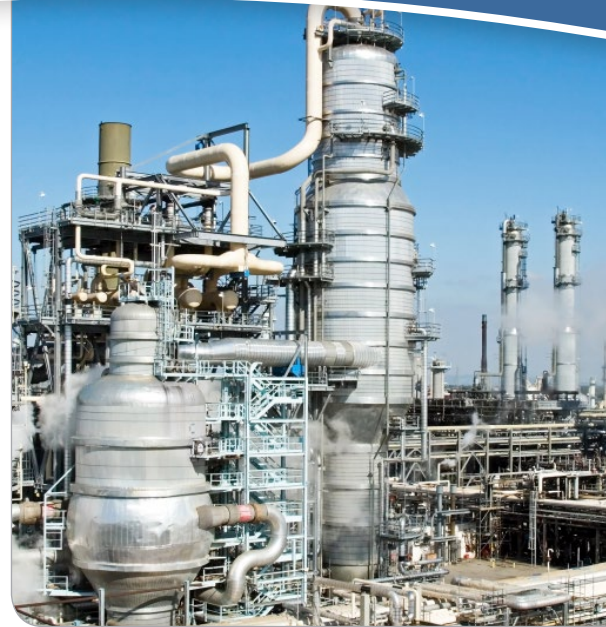
Figure 1: Photo of the Issue

As shown in Figure 2, the presence of water, carbon steel, and H<sub>2</sub>S produce ferric sulfide. In the presence of HCN (a gas that forms in FCC), ferric sulfide reacts to form atomic hydrogen. When it bonds with another hydrogen atom, there is a sudden strong increase in localized pressure as a result of the molecular hydrogen formation. This sudden pressure increase inside metal produces the blistering shown in Figure 1.

ChemTreat's recommendation was based on cutting the formation mechanism of the atomic hydrogen through the application of a film amine capable of forming a protective film on the carbon steel. The recommended product was Lipesa 229, and the point of injection was the feeding of destabilized naphtha to the stripping tower.
